Remediation of leakage of the hydraulic block presses MAC Master

Keywords: • hydraulic mold press • leakage • renovation • cylinder matrix block • MAC Master •

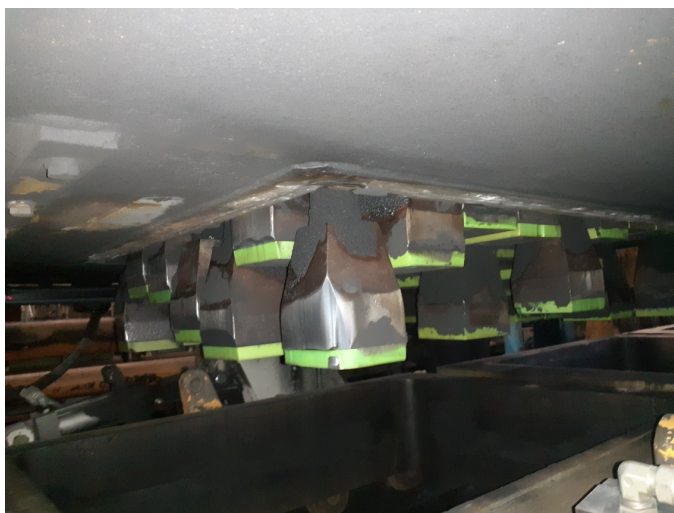
The main cause of intensive wear of the hydraulic components of the block is operation in an environment with the presence of foundry sand, which accesses all the "pores" of the hydraulic components, which is practically impossible to prevent. The abrasiveness of the foundry sand causes rapid wear of the piston rods and seals of the hydraulic cylinders, which is reflected in the ever-increasing bearing capacity. This causes an uneven distribution of compressive force (simultaneously) operating 63 hydraulic cylinders located inside a two-part steel block - dimensions 1360 x 1020 x 700 mm. The presence of the foundry sand on all parts of the press is shown in Figure 2.

Figure 2: Presence of foundry sand on the press.

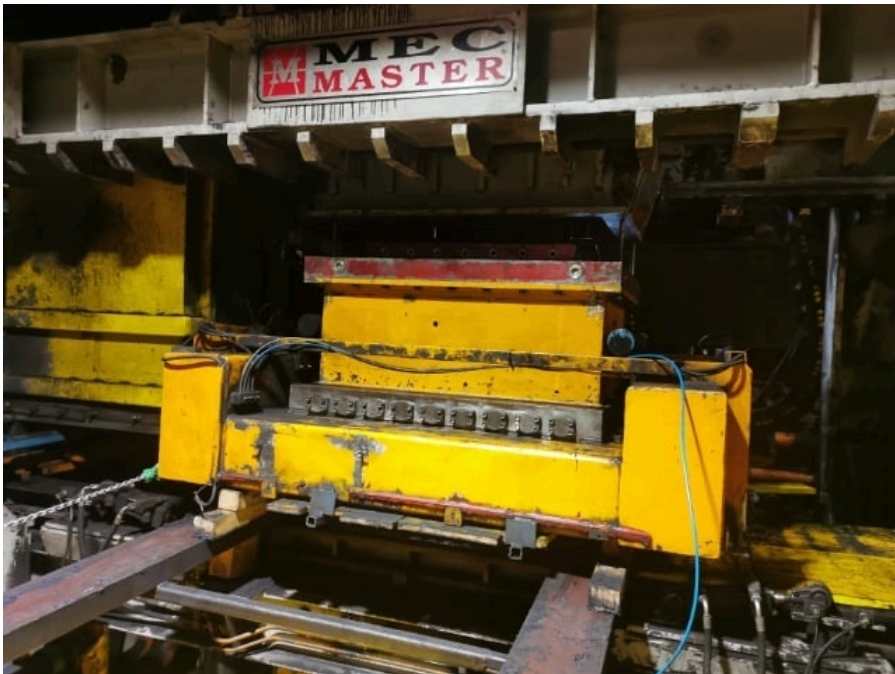
The dismantling of the entire hydraulic block (total weight 5.7 t) was a particular challenge due to the very limited space and obstacles around the press, as it was not possible to use any lift or forklift assistance. All disassembly had to be done manually, with the maintainers' own physical strength (Figure 3). In addition to the problem of dismantling, an economic condition was set regarding the price and scope of renovation. When preparing the offer, it was necessary to take into account an estimation that quarter of the existing 63 hydraulic cylinders will have to be replaced with new piston rods. In fact, more than half of the existing piston rods had to be replaced with new ones.

Figure 3: Physically released hydraulic block of the press.

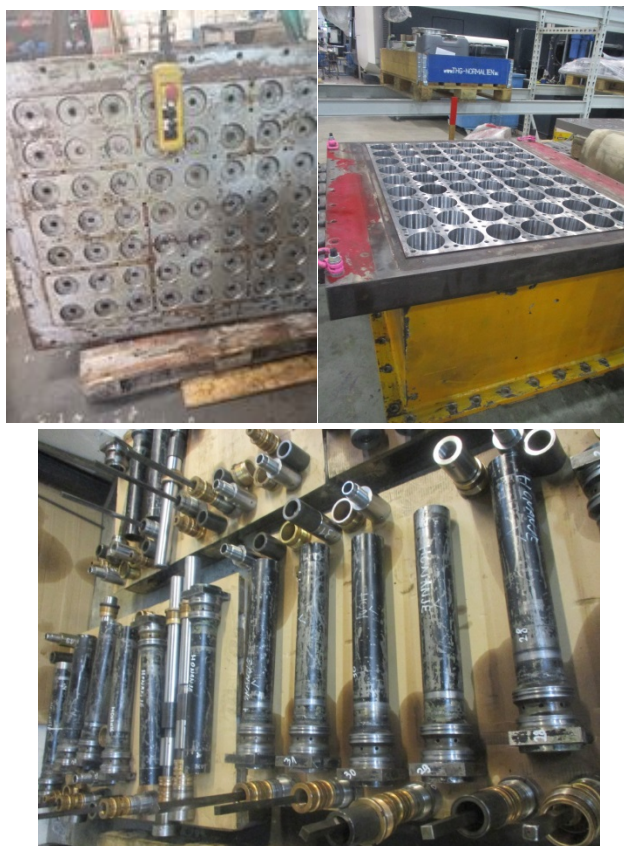
A further obstacle was also the modest technical documentation of the Italian-made press, as it did not contain a more detailed description of the hydraulic components. The only indication of the quality of the roller block design was the small engraving inside the hydraulic block. The logo of the manufacturer HUNGER, which was detected only after the separation of the cover and guide plate, indicated the fact that the block was manufactured by the company in the appropriate quality and thoughtful construction, and that it is a particularly demanding hydraulics. Due to the absence of documentation, it was necessary to dismantle the block according to the principle of hydraulic forensics - with real-time documentation and marking of individual parts - Figure 4.

Figure 4: Disassembly of the hydraulic block into component subassemblies.

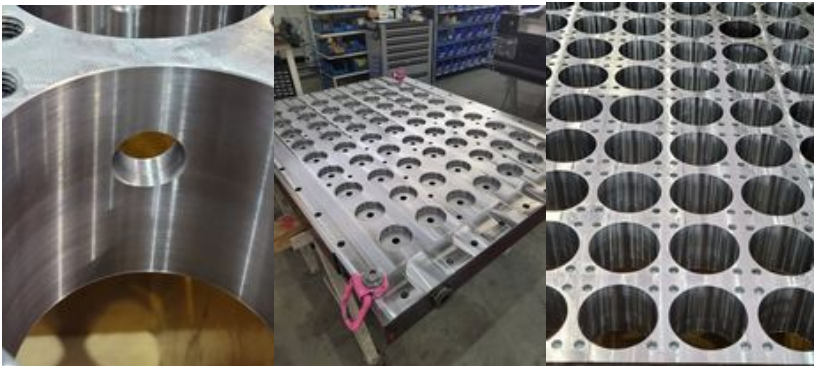
A particular challenge has been the treatment of the roller's seats due to the frequency of the pressure load and the mechanical already slightly bent cover of the hydraulic block (Figure 6). The lower and upper matrix 7 x 9 must match in a tolerance of ± 0.01 mm, otherwise the end roller would at best receive a hydraulic oil with a time gap, and at worst there would be a leakage on the hydraulic block immediately.

Figure 6: Cover and guide plate form roller housings

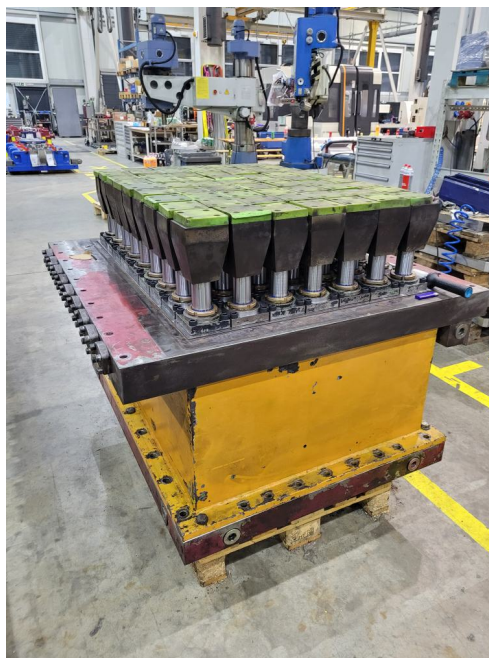
Figure 7: Hydraulic block prepared for transport.

Assembling individual cylinders and assembling a complex hydraulic block into a working whole, without prior sealing control, would be a rather risky act. Before transport from BOGADI Tesnila d.o.o. in LIVAR d.d. - PE Črnomelj, sealing control and simulation of simultaneous operation of all 63 hydraulic cylinders were performed.
